**Flood Control Project Maintenance
Levee Inspections**

Fall 2014 Levee Maintenance Deficiency Summary Report

Solano County Public Works Mellin Levee

Levee Inspection Report By Mile - Fall 2014

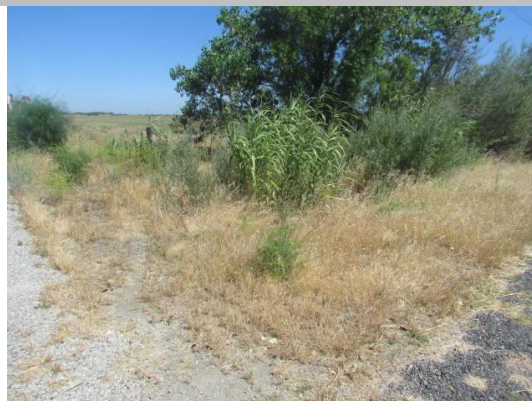
Photo 1 of 1 : FA_2014_NA0012_258_1_20141010_00001.jpg

LM Start	0.00	Rating **	M	Issue No.	1
LM End	0.00	Issue Type +	Ma	Location *	WS
Category	Earthen Levee			GPS Latitude/Longitude	
				Start	End
Item	Vegetation			38.174051 °	38.174051 °
				-121.674220 °	-121.674221 °
DWR ID	DWR_NA0012_01_s_2012_1				
Action/Comments					
Remove the wild growth other than native grasses from the levee slopes.					
Inspector Comments: Control Arundo on waterside slope at the entrance to the levee.

Looking west at arundo on waterside slope at entrance to unit.

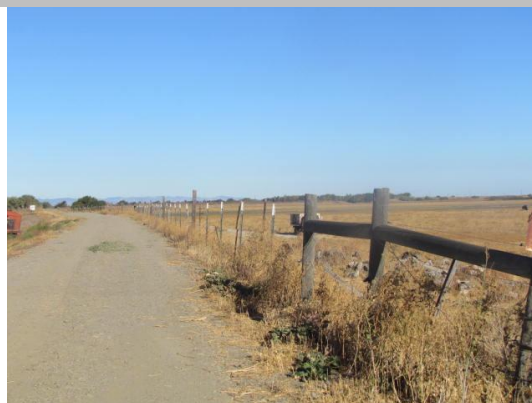
Photo 1 of 1 : FA_2014_NA0012_258_3_20141010_00003.jpg

LM Start	0.00	Rating **	M	Issue No.	3
LM End	0.59	Issue Type +	En	Location *	WS
Category	Earthen Levee			GPS Latitude/Longitude	
				Start	End
Item	Encroachments			38.174167 °	38.178960 °
				-121.674312 °	-121.680600 °
DWR ID	DWR_NA0012_01_s_2012_3				
Action/Comments					
Fence

Looking west at fence on waterside shoulder.

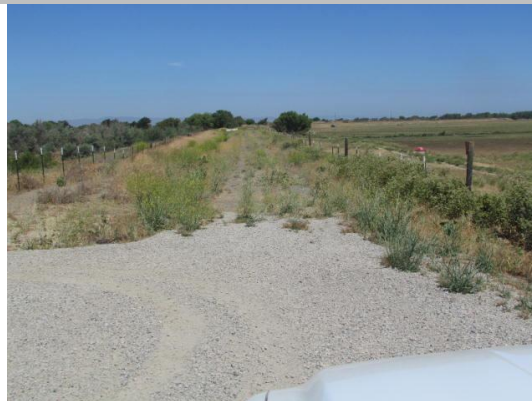
Photo 1 of 1 : FA_2014_NA0012_258_2_20141010_00002.jpg

LM Start	0.15	Rating **	A	Issue No.	2
LM End	0.59	Issue Type +	Ma	Location *	CR
Category	Earthen Levee			GPS Latitude/Longitude	
				Start	End
Item	Crown Surface / Depressions / Rutting			38.175618 °	38.178960 °
				-121.676190 °	-121.680600 °
DWR ID	DWR_NA0012_01_s_2012_2				
Action/Comments					
Add appropriate material and re-grade the levee to bring the crown above the design elevation.

Looking west at wild growth on levee crown.

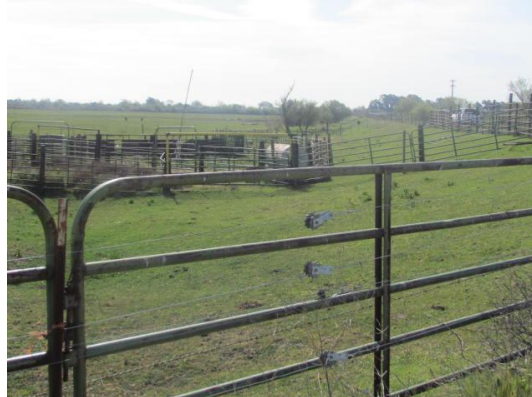
Photo 1 of 2 : FA_2014_NA0012_258_5_20141010_00004.jpg

LM Start	0.56	Rating **	M	Issue No.	5
LM End	0.59	Issue Type +	En	Location *	WS
Category	Earthen Levee			GPS Latitude/Longitude	
				Start	End
Item	Encroachments			38.179783 °	38.180027 °
				-121.681648 °	-121.681978 °
DWR ID	DWR_NA0012_01_s_2012_5				
Action/Comments					
Fence					
Inspector Comments: Animal corral.

Looking east at animal corral on waterside toe.

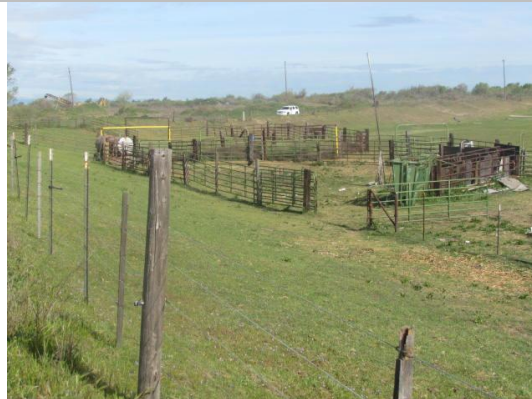
Photo 2 of 2 : FA_2014_NA0012_258_5_20141010_00005.jpg

LM Start	0.56	Rating **	M	Issue No.	5 (cont)
LM End	0.59	Issue Type +	En	Location *	WS

Looking west at animal corral on waterside toe.
